RADIO FREQUENCY INTERFERENCE EVALUATION OF A SINGLE SKIN S-2808--ETC(U)

HOL-TM-81-7

4. TITLE (and Subtitle) Radio Frequency Interference Evaluation of a Single Skin S-280B Shelter.		5. TYPE OF REPORT & PERIOD COVERED Technical Memorandum

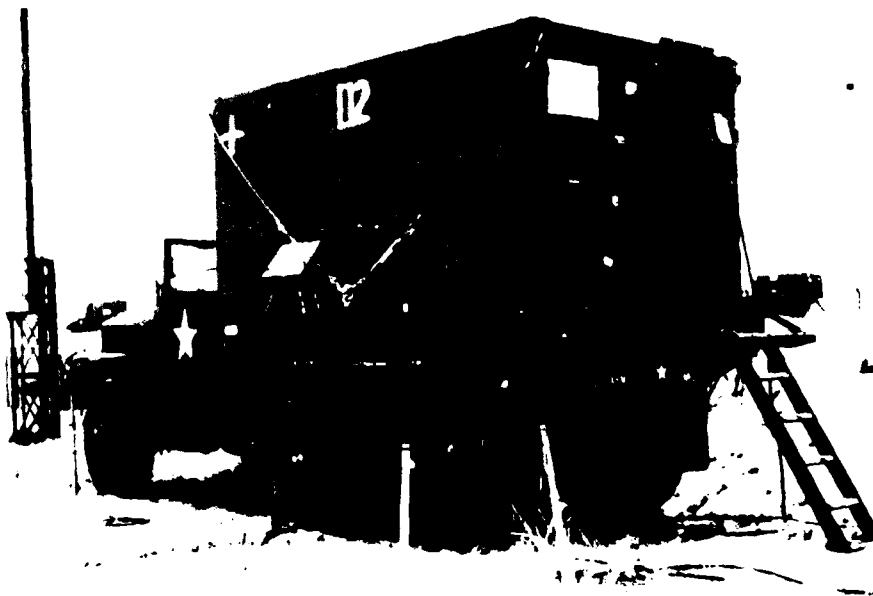
Figure 1. Present S-280 shelter.

The present S-280 (fig. 1) has two 0.030-in. (0.762-mm)-thick aluminum walls separated by 2 in. (5.08 cm) of insulating core material. The inner wall is carefully bonded electrically around most of the seams for continuous RFI shielding. The outer wall panels are riveted together, but sealed against only water and air. The shelter provides at least 60 dB of RFI shielding in accordance with MIL-STD-285¹ and often provides 80 dB or more.

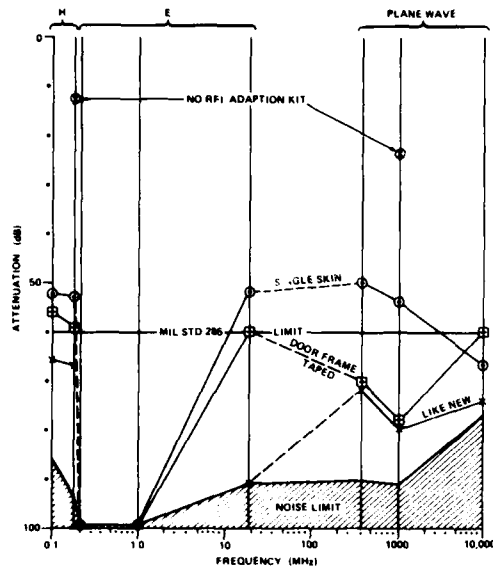
Figure 3. Measurements of S-280 shelter for RFI shielding; lines connect data points only for identification.

The E-field, H-field, and plane waves were measured from 100 kHz to 10 GHz (fig. 3, 4). The receiver was tuned to the desired frequency, and the gain was adjusted for a noise level of 0 dB. Next, the oscillator was turned on, the antennas were set 25 in. (63.5 cm) apart,

and the reference on the receiver input attenuator was read. Then the door was closed, and the new receiver level attenuation was measured. The shielding is the difference in level between the two attenuation readings.

A complete series of tests was done (app A, test sheets 2 to 9). The worst case shielding levels were noted (table 2) and plotted (fig. 3, "LIKE NEW"). The front and back panels tended to leak more at the seams than did the side panels, probably because of the poorer construction of the front- and back-panel seams. The front and back inner walls are joined to the side walls and ceiling by the poorer V-groove channel (fig. 5, sect. C-C). The side inner walls are joined to the floor and the ceiling by the better method (fig. 5, sect. Y-Y). The two plane surfaces overlap, are bonded together with RFI sealing compound, and are riveted at 3- to 4-3/16-in. intervals.

The rear outer skin was removed next (fig. 7), and a complete run of data was taken (app A, test sheets 12 to 19; table 2 and fig. 3, "SINGLE SKIN"). The attenuation dropped from about ≥ 70 to 50 dB. The one weak spot in RFI shielding is the junction of the inner skin and door frame (fig. 8). The paint and some of the environmental sealer were stripped away (fig. 9). The end of the inner skin and the metal of the door frame are apart by about 1/4 in. (0.63 cm). The inner skin is isolated from the vertical aluminum structural member by a thin wood thermal barrier. The 1/4-in. gap is partly filled with bonding cement that joins the inner skin to the foam and wood core. The entire seam is then covered with weatherproof elastomer (fig. 9, seam detail with elastomer partly pulled away). Even if the rivets make good electrical contact with the inner skin and the aluminum structural member, there is a controlled gap between the metal surfaces of about 1/4 in. due to the thin wood thermal barrier.

The shielding recorded in figure 3 indicates that the seams and the door gaskets appear to contribute to the lower level of isolation. If it is required that a single skin shelter have 80 dB with no cutouts, then a better construction system is needed such as welding all seams. If welded seams or their equivalent cannot be obtained, then multiple layers with all RFI joints should be used. Even though the outer skin on the shelter was not sealed against RFI, it contributed to the RFI isolation.

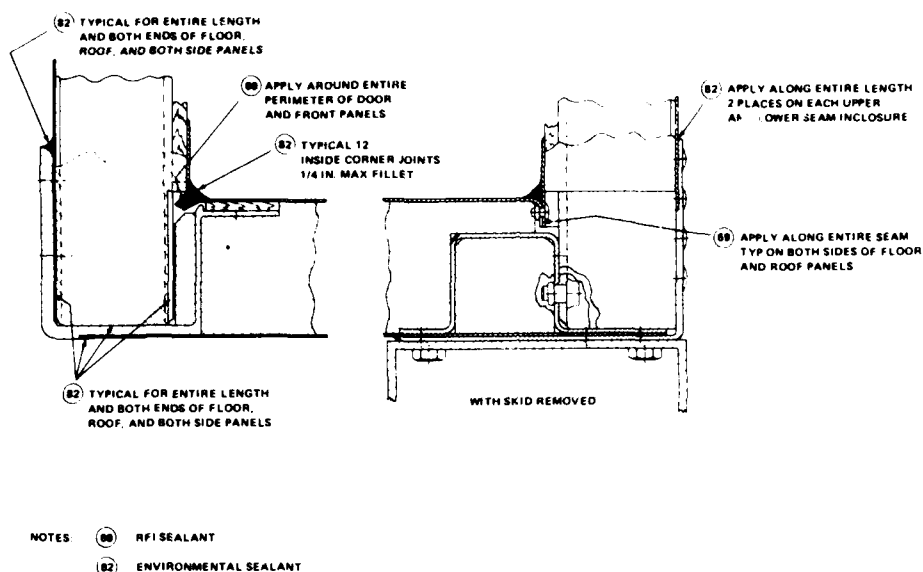
Figure 5. Inner skin joints (dwg m).

d. The interior end walls are joined to the ceiling, walls, and floor by channels with the interior walls angled to come close to each other and form a V-groove channel that almost touches. This channel is filled first with Chomerics RFI sealer and then with environmental sealer (dwg m).

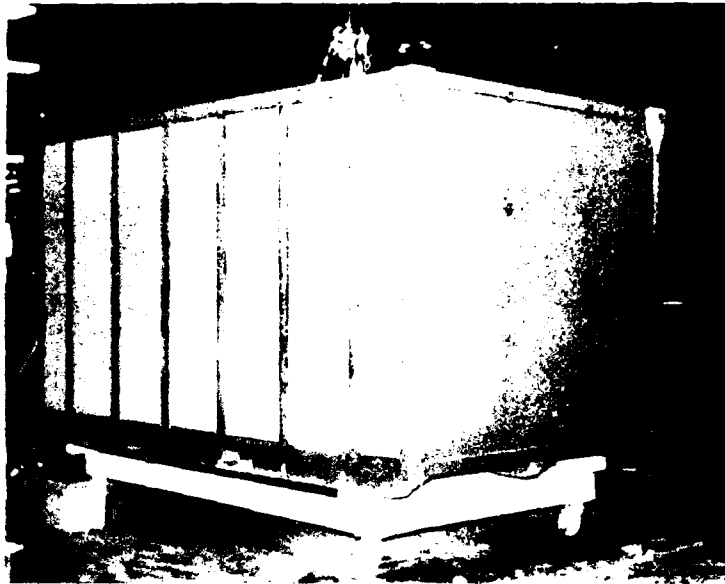
Figure 6. S-280 shelter with outer skin removed from curb side.

After those tests, the next step in the evaluation was to remove the outer skin from the curb side (fig. 6). There was an obvious source of radiation from the curb side, especially at 175 kHz (app A, test sheets 10 and 11).

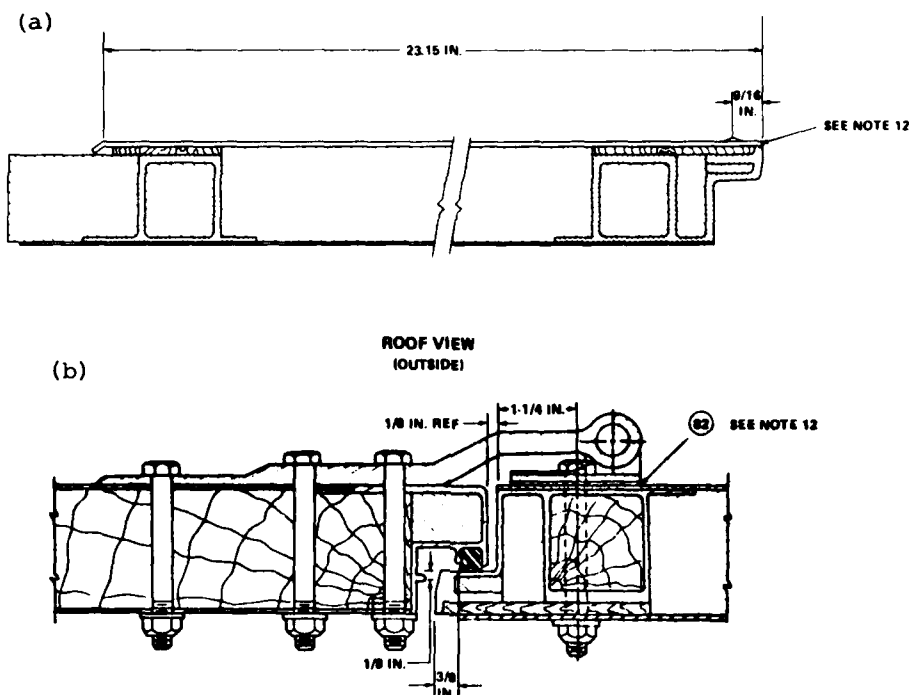
Figure 8. Interface of door frame and skin: (a) inner skin up and (b) inner skin down (dwg aa and k).

b. There is a design fault in continuity at the juncture of the rear wall inner skin and the outer door jamb (dwg aa, zone 4B, "SEE NOTE 12"). (Drawing Z, note 12, calls out item 24 adhesive or item 25 sealer, neither of which is specified for RFI applications. App A sheet 1 calls out 44 rivets on the jamb side, 24 on the bottom, 16 on the top, and ~24 on the hinge side.)

NOTE: (82) ENVIRONMENTAL SEALANT

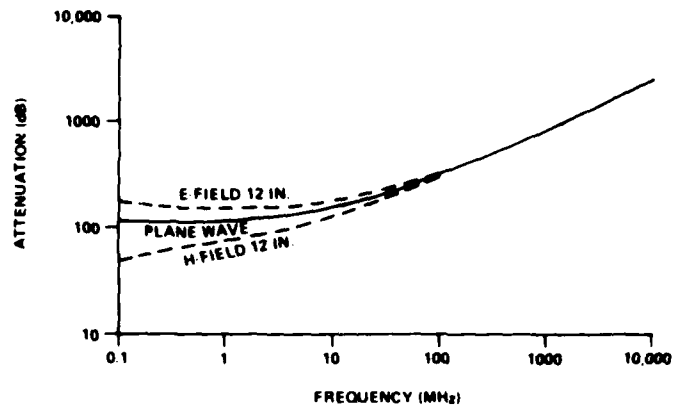
Figure 11. Theoretical attenuation of 0.030-in.-thick aluminum.

The shelter provides shielding over a broad range of frequencies including those of interest for high-altitude EMP (HEMP). Any HEMP should experience the same 60 dB or more attenuation characteristic of the E-field and plane wave measurements since the source of the HEMP is at a long distance.
